HAZARDOUS MATERIALS SURVEY REPORT

Valley Centre Business Park

184 South 6th Avenue
City of Industry, California 91748

July 26, 2024

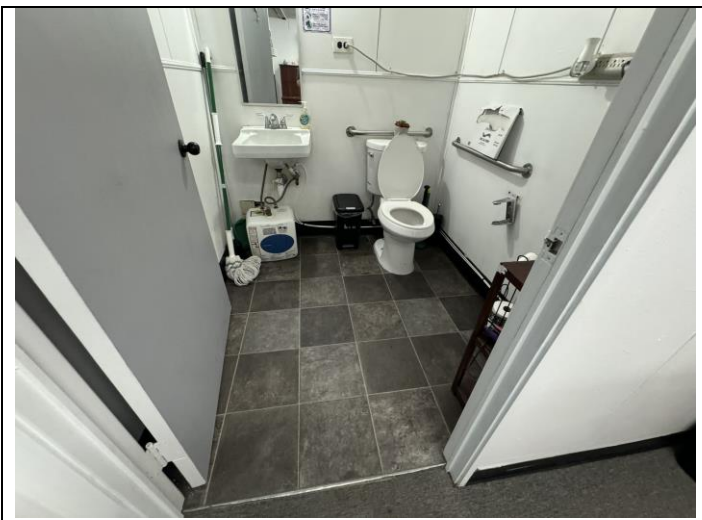
11. View of typical restroom Dark Gray Square Pattern Vinyl Sheet Flooring/Mastic with >1% asbestos.

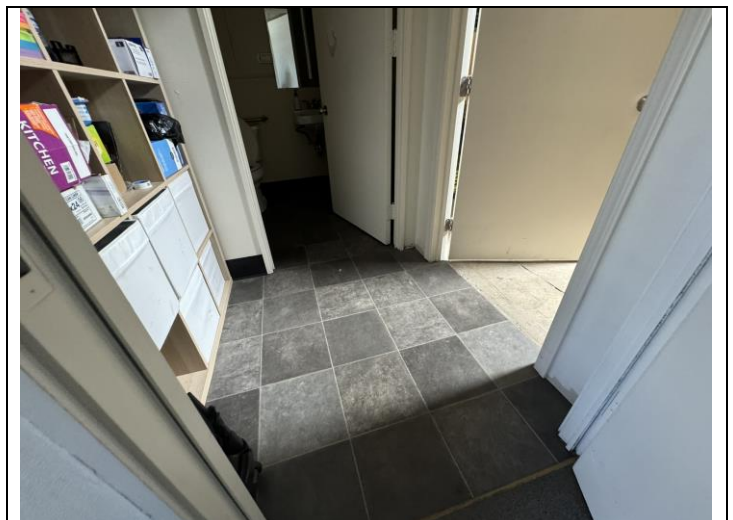
12. View of typical Hall space and Dark Gray Square Pattern Vinyl Sheet Flooring/Mastic with >1% asbestos.

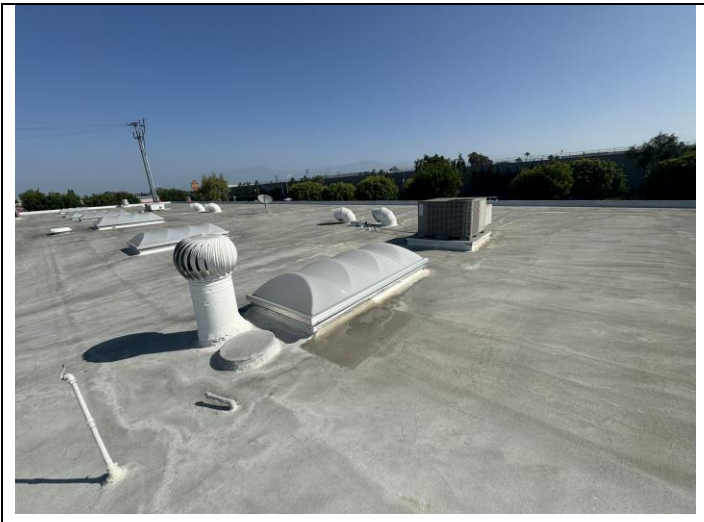
- **Roof Penetration Mastics**, Good Condition, Category I, Non-friable (2%-3% Asbestos), Located on the base of HVAC units, sun lights and roof vents and pipe penetrations on the roofs of 100, 120, and 172 South 6th Avenue and 14404 Valley Boulevard – Estimated 150-250 Square Feet per building- Approximately 150-250 square feet per building (850 sf. total)

15. View of typical roof vents, penetrations and sun lights with penetration mastic >1% asbestos.

The USEPA recommends that all ACM be removed by a certified asbestos abatement contractor prior to any renovation or demolition activities that may impact the material. In the absence of planned renovation/demolition activities, the USEPA recommends that ACM be managed in place whenever asbestos is identified in a building. Any damaged ACM should be removed, repaired, encapsulated, or enclosed. ACM that are not damaged may be managed in place in accordance with a written Operations and Maintenance Program.

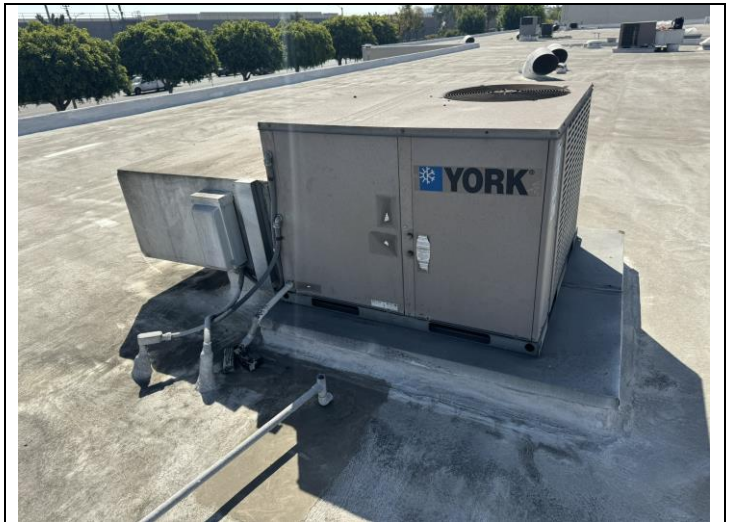
16. View of typical roof penetration mastic >1% asbestos at base of roof HVAC units.

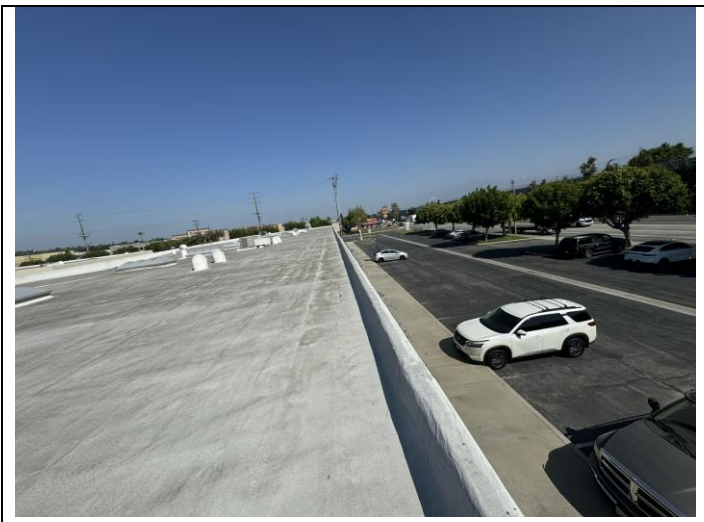
- **Parapet Wall Cap Seam Mastic**, Good Condition, Category I, Non-friable (2%-3% Asbestos), Located on parapet wall cap seams on 156 and 172 South 6th Avenue – Estimated 200-250 Square Feet per building- Approximately 200-250 square feet per building (450 sf total)

17. View of typical parapet wall cap seam mastic with >1% asbestos.

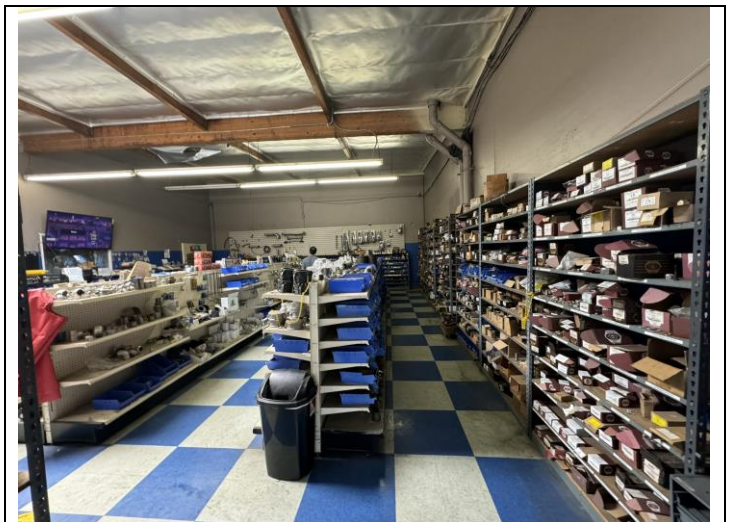
18. View of White 12"x12" VFT/Mastic with >1% asbestos in 184 South 6th Avenue store, offices and restrooms.

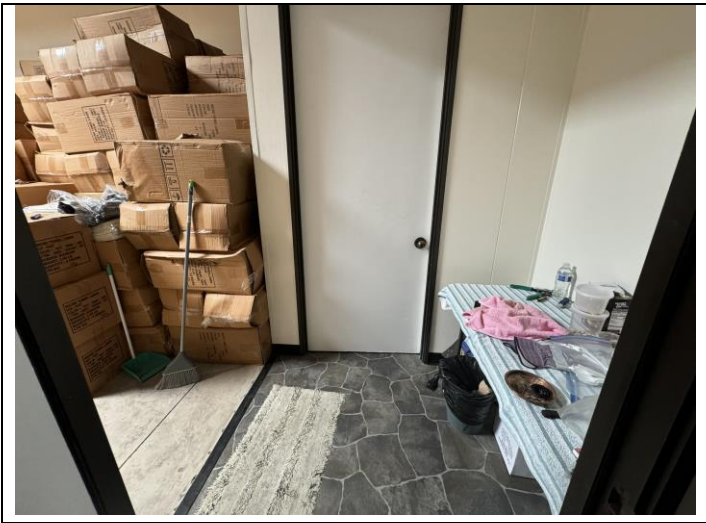
19. View of Gray Rock Pattern Linoleum/Mastic with >1% Asbestos in 102 South 6th Avenue hall and restroom.

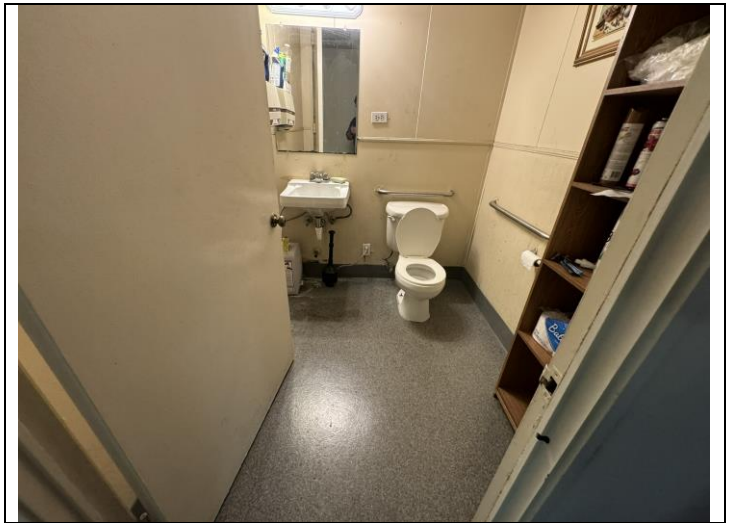
- **Gray Linoleum/Mastic**, Good Condition, Category I, Non-friable (5% Asbestos), Located in the restrooms at 178 South 6th Avenue – Estimated 100 square feet.

20. View of Gray Linoleum/Mastic with >1% asbestos in 178 South 6th Avenue restrooms.

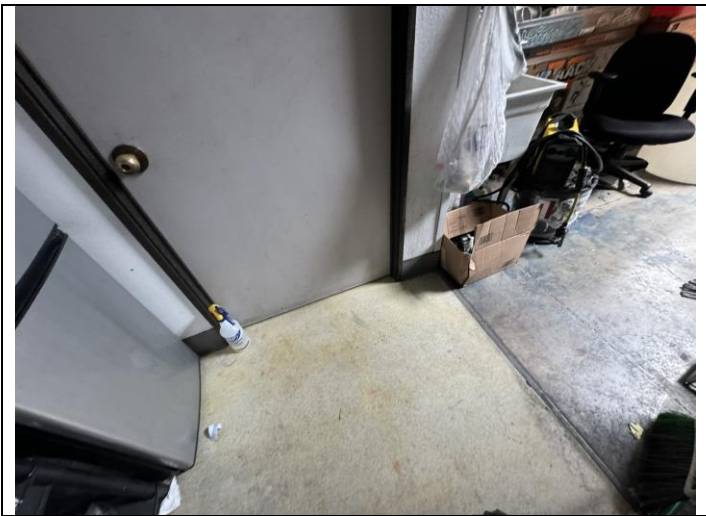
- **Cream Linoleum/Mastic**, Good Condition, Category I, Non-friable (2% Asbestos), Located in the restrooms and hall at 190 and 112 South 6th Avenue – Estimated 230 square feet

21. View of Cream Linoleum/Mastic with >1% asbestos in 112 and 190 South 6th Avenue halls and restrooms.

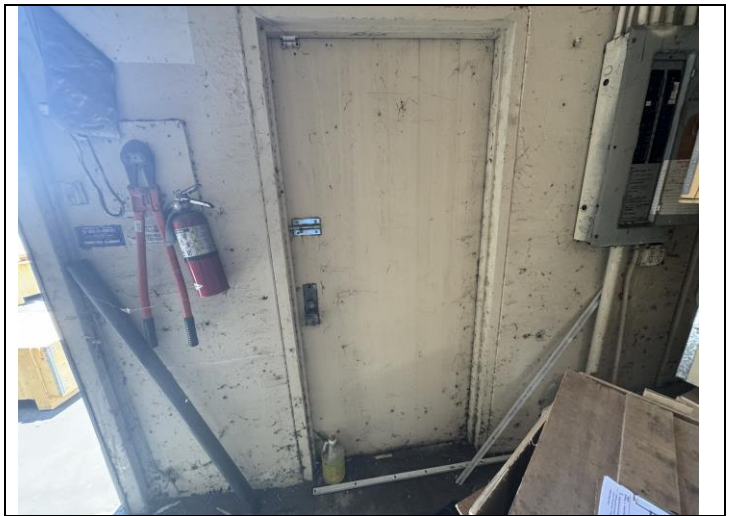
22. View of Cream Paint on metal door and door frame with Lead >1.0 mg/cm² at 190 South 6th Avenue warehouse door.

It is understood that the property is scheduled for renovations and/or major conversion. Contractors performing renovation, repair, and painting (RRP) projects that disturb LBP must be certified and must follow specific work practices to prevent lead contamination.

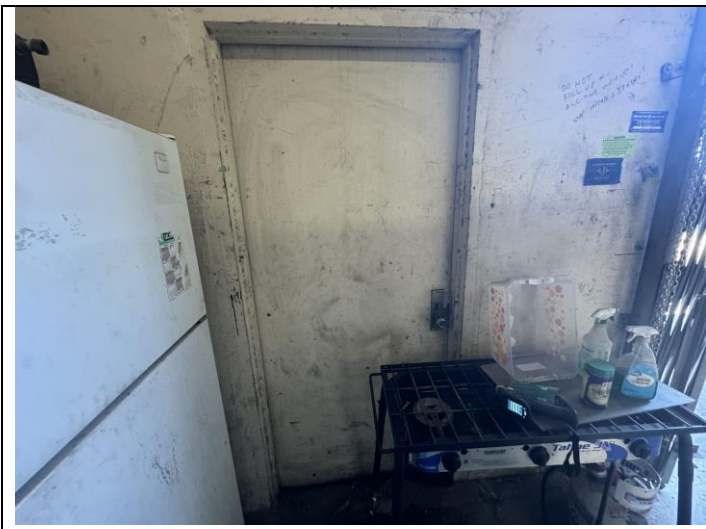
23. View of Cream Paint on metal door frame with Lead >1.0 mg/cm² at 184 South 6th Avenue warehouse door.

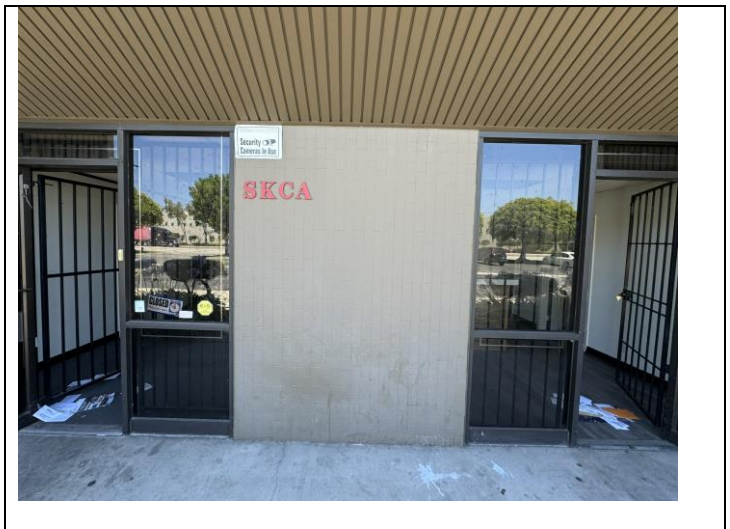
24. View of typical brown paint on exterior ceramic entry wall with lead >1.0 mg/cm².
